IronPlanet | Item #356190 - 2008 Terex T 775 Hydraulic Truck Crane

## Item #356190 - 2008 Terex T 775 Hydraulic Truck Crane

## Inspection Report

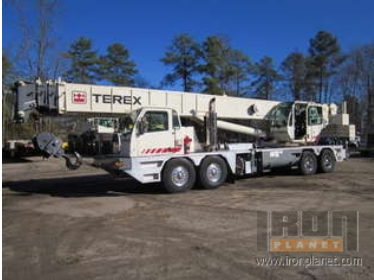
Safety Certification Report	Yes	
Load Chart	Yes	
Max Lift Capacity	75 Ton rated max lift capacity	
CE Mark	No	
Paint	Scratches; Chips; Touch up paint	
Sheet Metal (fiberglass) Condition	Minor dents; Scrapes; Surface rust in areas	
Steps/Ladders	No visible damage	
Hand Rails	No visible damage	
Picture, Left Front Corner

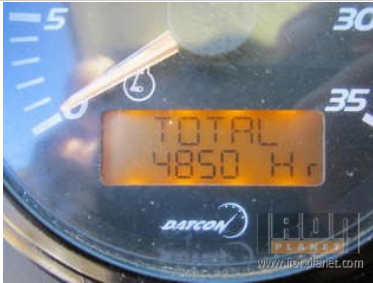
Item	Assessment	Photo
Mirrors	★★★★☆ No visible damage	
Glass	★★★★☆ No visible damage	
Seats/Armrests	★★★★☆	
Seat Belts	Operational	
Horn	Inoperable	
Steering Controls	★★★★☆	
Drivetrain Controls	★★★★☆	
Oil Pressure	The fault indicator shuts off after the engine oil pressure rises.	
Exterior Lights Operational	Yes	
Engine Warning Lights	Operational	
Gauges	Operational	
Hour Meter/Odometer	4850. Hours; 0 Miles; Operational hour meter; Inoperable odometer

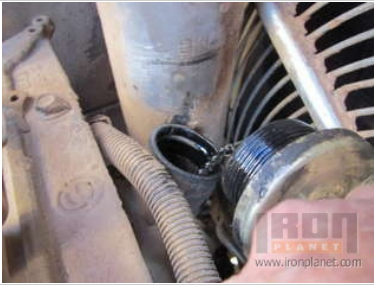
Starter	Operational	
Turbo or Blow er	Operational	
Injector Pump	Operational	
Exhaust System	No visible damage	
Radiator	★★★★☆	
Oil Leaks	There is fluid accumulation around the valve cover and on the side of the engine.	
Fuel Leaks	None seen	
Cooling System Leaks	None seen	
Air Compressor	★★★★☆ Operational	
Limited Function Check	The engine started and ran. See oil report.	
Engine - Carrier #1

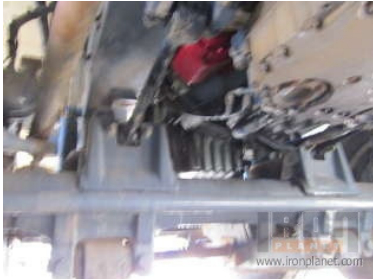
Chassis		
Item	Assessment	Photo
Steering Linkage	☆☆☆☆ Minor to moderate movement	
Steering Wheel Play	Minor to moderate movement	
Brake Type	Air	
Master Cylinder/Brake Control	☆☆☆☆	
Brake Lines/Hoses	☆☆☆☆	
Park Brake	☆☆☆☆ Stopped the machine while rolling	
Limited Function Check	The brake system functioned, stopping and holding the machine.	
Springs/Hangers Condition	☆☆☆☆	
Suspension Air Bags	☆☆☆☆	
Frame Condition	☆☆☆☆	
Cross Members	☆☆☆☆	
Tire Size	445/65R22.5 Front tires; 315/80R225 Rear tires; ALL MICHELIN	
Tire Condition	Minor cuts and gouges	
Tread Depth	LF 20,21 /32"; RF 20,25 /32"; RMO 15 /32"; RMI 20 /32"; LMI 11 /32"; LMO 11 /32"; RRO 7 /32"; RRI 7 /32"; LRI 10 /32"; LRO 10 /32"	
Wheel Condition	☆☆☆☆ All Aluminum	
Wheel Studs	☆☆☆☆	
Outrigger Beams	☆☆☆☆	
Outrigger Cylinders	☆☆☆☆	
Outrigger Pads	☆☆☆☆	
Main Boom Pins	☆☆☆☆ Minimal movement	
Main Boom Sections	☆☆☆☆ Boom dolly brackets have been removed.	
Sheaves	☆☆☆☆

Boom Head Section	☆☆☆☆	
Boom Extension Condition	☆☆☆☆	
Wear Pads	☆☆☆☆ Minor to moderate movement	
Boom Length	126' Extended boom length; 40' Minimum boom length; 57' jib (extended) 32' jib (retracted)	
Boom/Jib Extension	☆☆☆☆ 57' Long; Swing Away (side mounted)	
Boom Angle Indicator	☆☆☆☆	
Turn-table Bearing	☆☆☆☆	
Bottom Covers	☆☆☆☆	
Limited Function Check (rough terrain)	The main crane components functioned when checked without a load.
