IronPlanet | Item #356190 - 2008 Terex T 775 Hydraulic Truck Crane

## Item #356190 - 2008 Terex T 775 Hydraulic Truck Crane

## Inspection Report

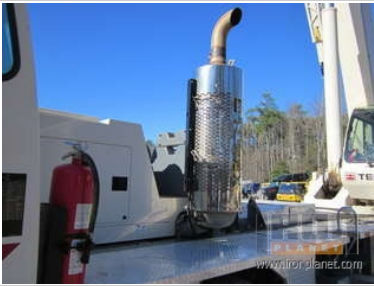
Engine - Carrier #2

Starter	Operational	
Turbo or Blow er	Operational	
Injector Pump	Operational	
Exhaust System	No visible damage	
Radiator	★★★★☆	
Oil Leaks	There is fluid accumulation around the valve cover and on the side of the engine.	
Fuel Leaks	None seen	
Cooling System Leaks	None seen	
Air Compressor	★★★★☆ Operational	
Limited Function Check	The engine started and ran. See oil report.	
Engine - Carrier #1

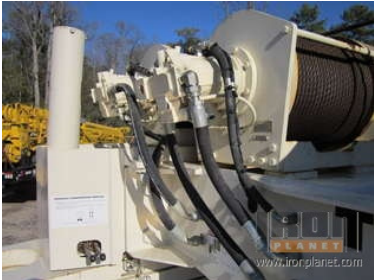
Hydraulics #2

Hydraulics		
Item	Assessment	Photo
Pumps (Hydraulics)	☆☆☆☆ Fluid accumulation	
Hydraulic Motors	☆☆☆☆	
Valves	☆☆☆☆ Fluid accumulation	
Hydraulic Tank	☆☆☆☆	
Hoses (Hydraulic)	☆☆☆☆	
Sw ing Motor	☆☆☆☆	
Main Hoist	☆☆☆☆	
Auxiliary Hoist	☆☆☆☆	
Lift Cylinders	☆☆☆☆ Fluid accumulation	
Telescope Boom Cylinders	☆☆☆☆	
Cylinder Pins and Bushings	☆☆☆☆ Minor to moderate movement	
Limited Function Check	The hydraulic system w as operational without a load. See oil report.	
Hydraulics #1

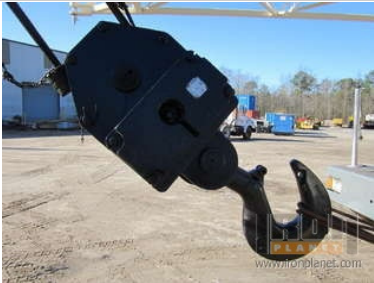
Specialty - Crane #2

Specialty - Crane		
Item	Assessment	Photo
Main Load Block	★ ★ ☆ ☆ JOHNSON brand load block; Model: QRJ750N16RTC; 75 TON capacity load block; Safety latch missing	
Overhaul Ball	★ ★ ★ ☆ Brand: JOHNSON; Capacity: UNKNOWN; Minor wear; Moderate wear	
Specialty - Crane #1
