Certificate of Inspection and/or Rated Load Test

Certificate Number: 17216

Description/Type: Mobile Hydraulic Crawler Crane

Manufacturer: Link Belt

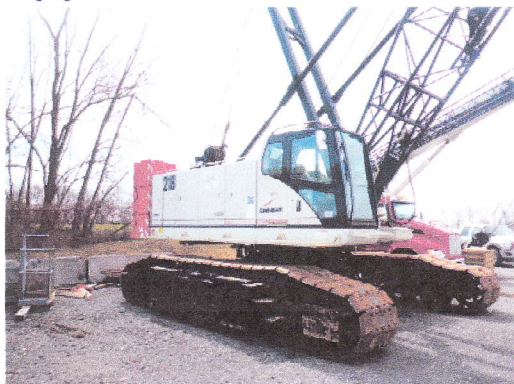
Model Number: HSL 218 Hylab

Rated Capacity: 110-Ton

Boom Length: 120' (Main) **Type:** Tubular Chords & Lacings

Jib Length: 5' **Type:** Off-Set Rooster (Whip-Line)
